EVALUATION OF XM20 AND XM20E1 LANDING  
MATS UNDER HEAVY-DUTY LOAD

Army Engineer Waterways Experiment Station  
Vicksburg, Mississippi

December 1972

MISCELLANEOUS PAPER S-72-39

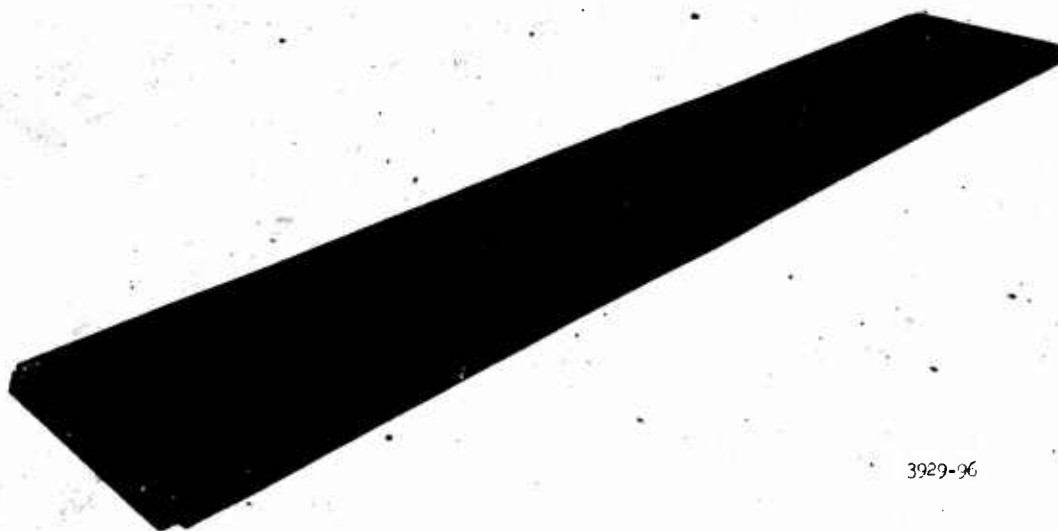
Fig. 1. XM20 landing mat panel

8. The XM20 mat panels are one-piece hollow extrusions with 12 internal vertical ribs. The panels (fig. 1), which are 1-1/2 in.

thick, 2 ft wide, and 12 ft long, were fabricated from 6061 aluminum alloy. The extrusions are artificially aged to the T6 condition, which involves solution heat treatment and oven cycling to produce a stable temper. The panels are interlocked along the sides by means of a hinge-type connector, the components of which are an integral part of the basic panel extrusion. Short tubes matching the inside contours of the mat extrusion are inserted into each cavity and welded flush with the ends of the basic extrusion. The extruded end connectors, consisting of an overlap and underlap section, are then welded to the basic

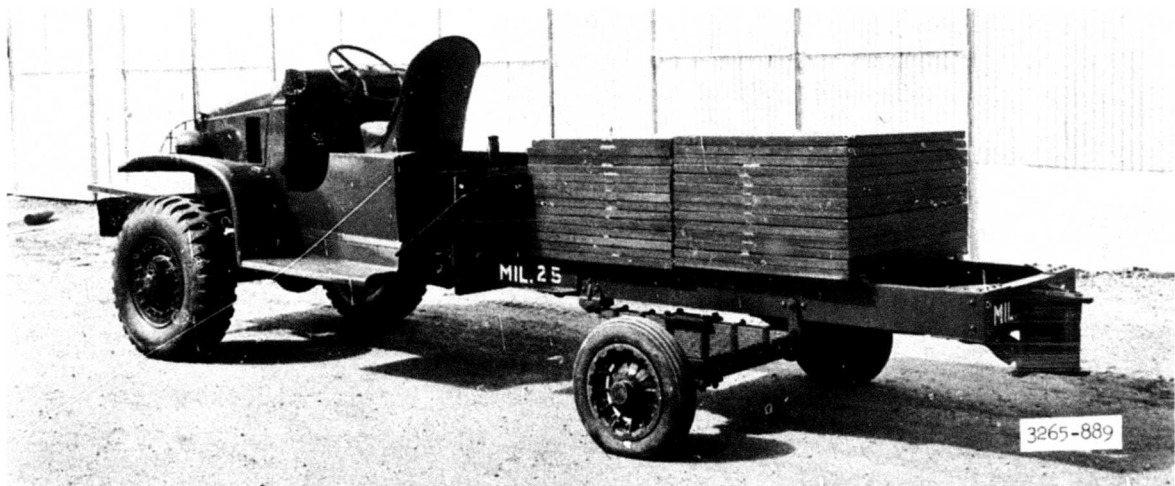
Fig. 7. Skid cart used in skid-resistance and tire-wear tests on XM20 mat

19. Skid tests on the XM20 mat were performed prior to the traffic tests on both dry and wet surfaces with a pneumatic-tired, two-wheeled skid cart (fig. 7). The cart was loaded to achieve 10,000 lb

on each rear wheel, and the tires were inflated to 200 psi. Two 26.00x6.6 tires, each with a contact area of 53 sq in. and an average contact pressure of 190 psi, were used on the skid cart. The truck section of the skid cart was used for steering, and a tractor was used to pull the skid cart.\*

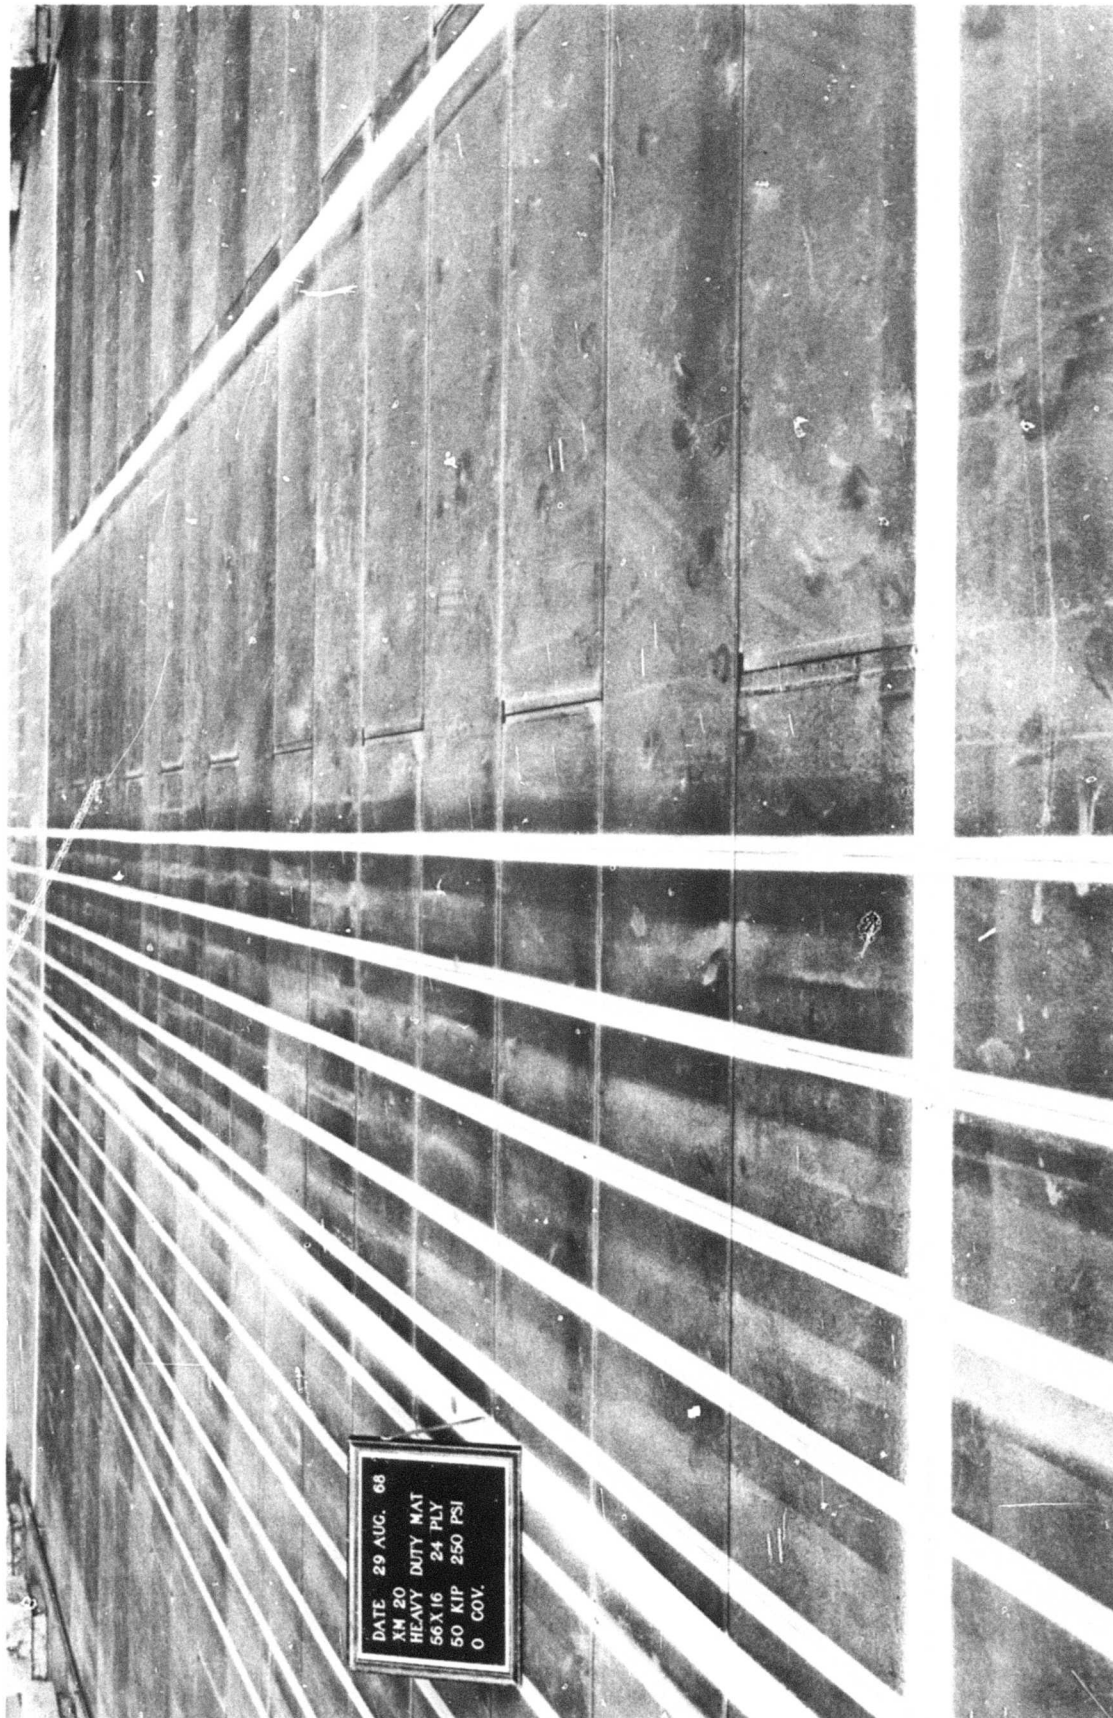
(photo 2). After 10 coverages of traffic, slight curls of the top lips of the female connectors at the female/overlap and female/underlap corners of all mats had occurred. A 5/8-in. break had developed in the weld between the extrusion and the underlap connector at the female/underlap corner of the AM2 repair panel after 22 coverages (photo 3). The curls of the female/end connector corners of the XM20 panels increased slightly until 40 coverages; thereafter, the curls did not show a significant increase until nearer the end of the test. The two edge screws on the underlap connector of the repair panel had stripped from the lower adapter of this connector after 54 coverages, allowing some separation between this panel and panel 2. After 124 coverages the repair panel was considered failed due to the curl at the female/underlap corner (photo 4). The three center screws in the underlap connector were separated from the top part of this connector, and the two end screws were stripped out. The curl and the separations were considered a tire hazard. The positions of panels 1 and 2 were interchanged in the test section to move the tire hazards outside the traffic lane, and traffic was continued.

Photo 2. XM20 test section prior to traffic

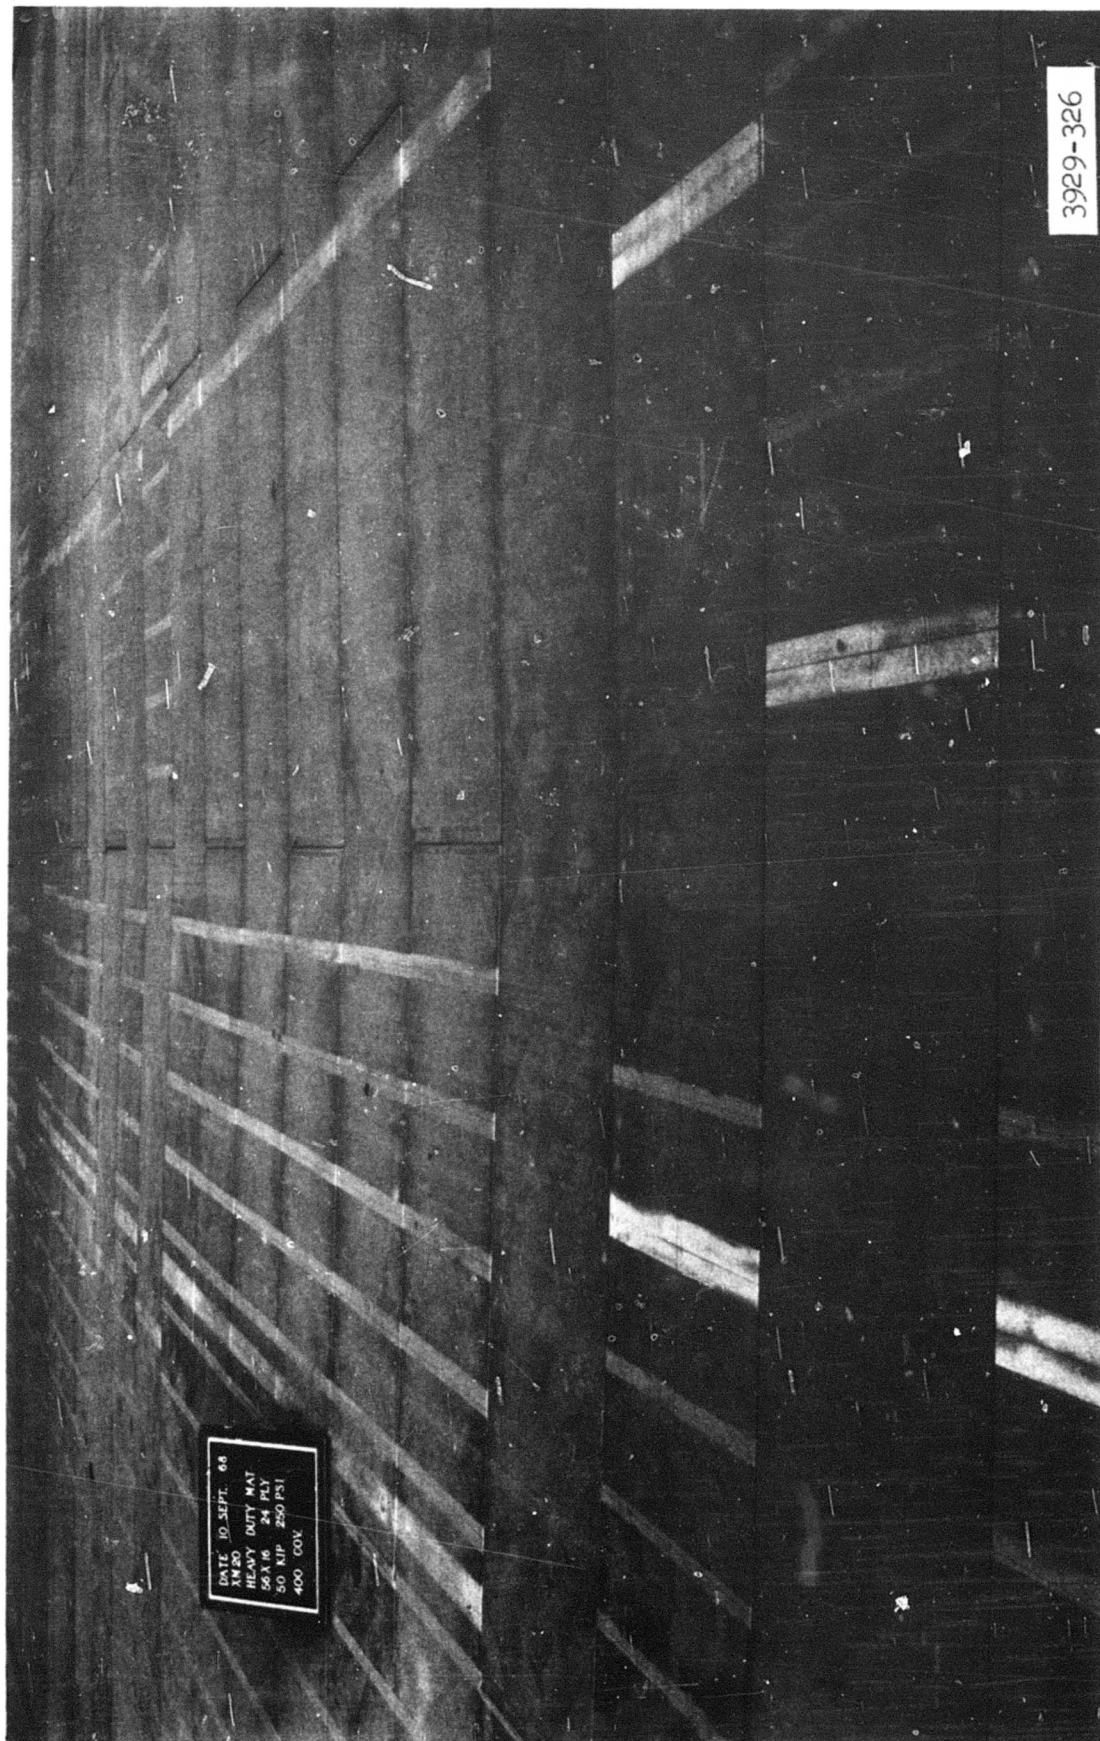
Photo 11. XM20 test section at completion of testing. Section considered failed
